Deck, balcony and window safety

A guideline for the use, inspection and maintenance of decks, balconies and windows

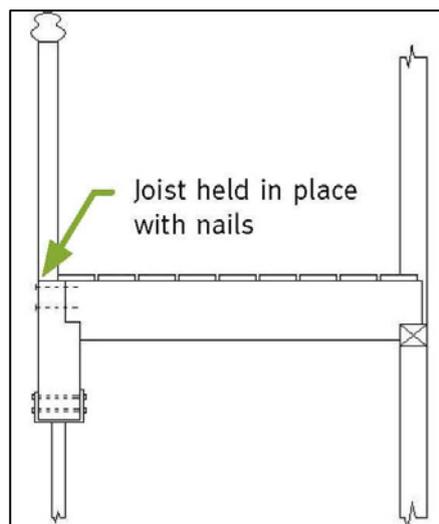
Figure 1: Pre-1940s deck construction with a cogged out beam holding the joist with nails.

Figure 1 shows a typical construction method for pre-1940s decks. The beam (or bearer) is cogged out to hold the joist. The joist is held in place with nails. This was the joining method used on the collapsed deck.

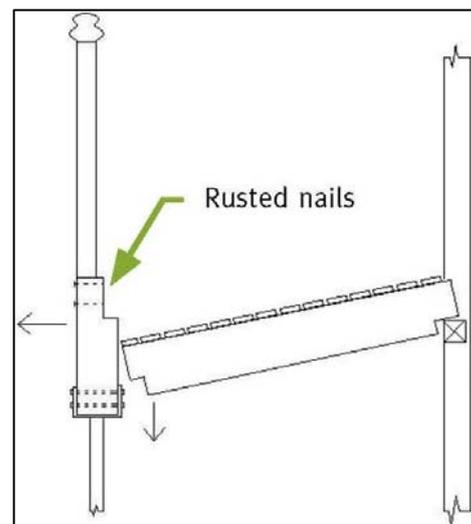
Figure 2: Old nails can rust out causing structure to collapse.

In this type of construction method, the ends of the joists are concealed by the bearer in the area where the joist rests. Over time, the nails can rust out, the beam can bow outwards and the joist can separate, potentially resulting in structure failure or collapse as shown in **Figure 2**.

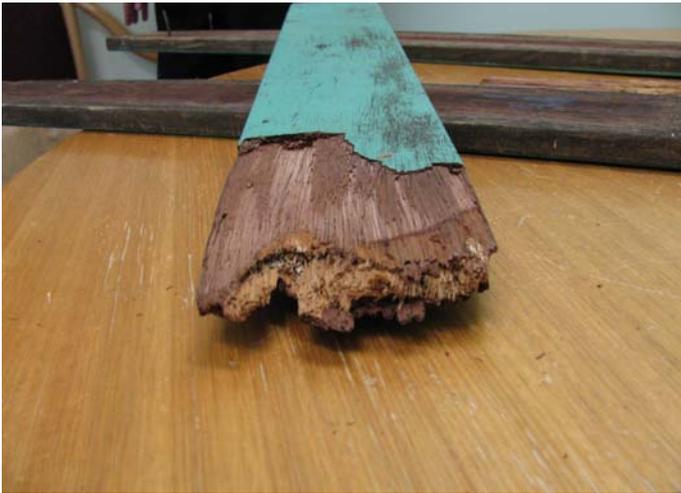
One of the decayed decking boards from the 2010 accident.

In May 2010, the Rockhampton Coroner released findings from an investigation into a death caused by a decayed decking board.

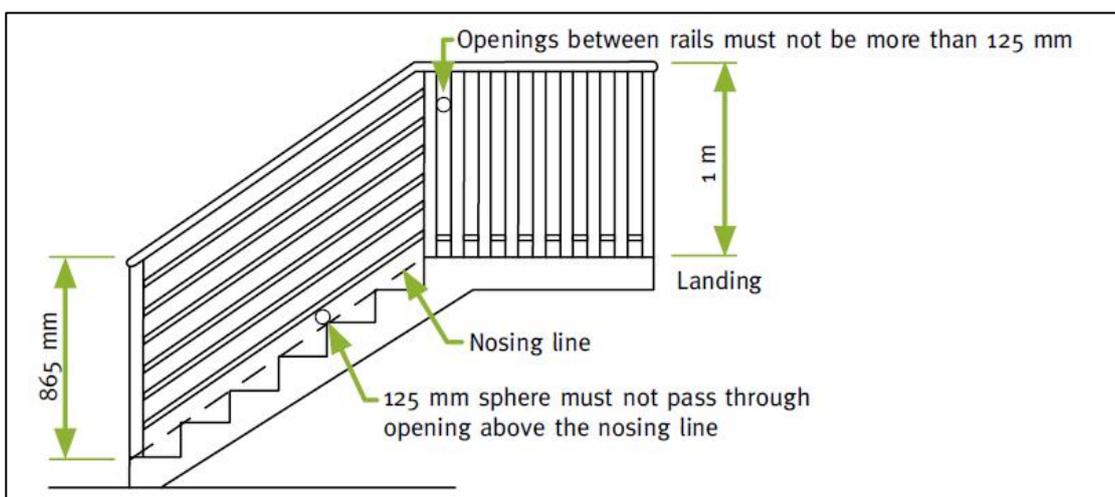
Figure 3: Balustrade or other barrier construction (Courtesy: Australian Building Codes Board).

Requirements for balustrades differ depending on the height of the deck or balcony above the ground. For decks or balconies more than one metre above the ground, a balustrade cannot have any openings greater than 125 millimetres, to help prevent people from falling through them. This is also a requirement for decorative balustrades. For decks or balconies more than four metres above the ground, a balustrade must also not have any climbable elements, such as horizontal rails, located between 150 millimetres and 760 millimetres from the floor.

Where a deck or balcony is one metre or higher above the ground, balustrades need to be at least one metre high.

For decks more than one metre above the ground, openings in balustrades, including decorative balustrades, cannot be greater than 125 millimetres.

For decks more than four metres above the ground, balustrades cannot have any climbable elements located between 150 millimetres and 760 millimetres from the floor.

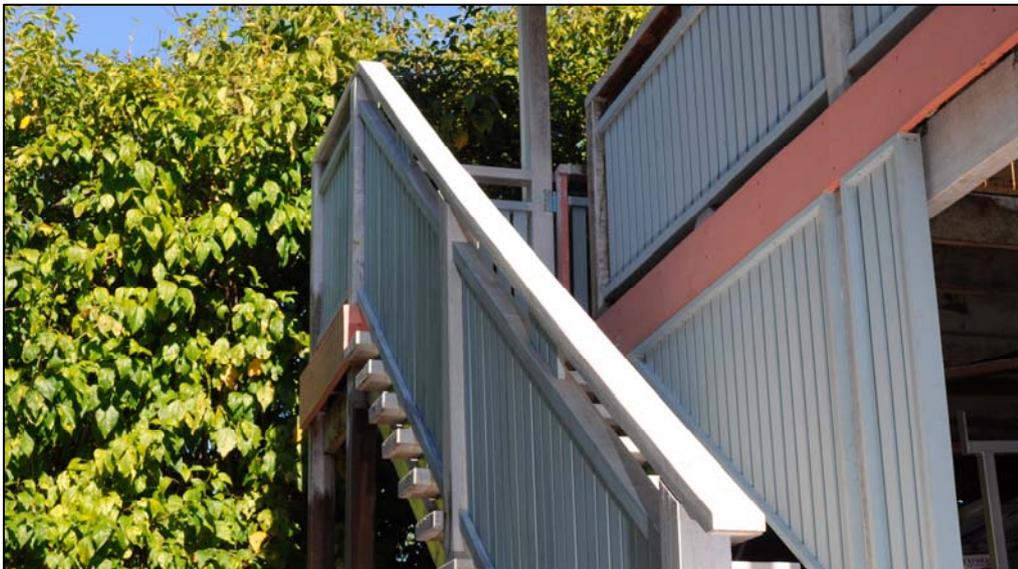
Stairs require a similar barrier to decks and balconies.

For stairs, a barrier of at least 865 millimetres high above the 'nosing' of the stair treads is required. The 'nosing' of the stair treads can be measured by placing a string line, or straight object, where each stair tread begins, forming a slope. The measurement of 865 millimetres can be taken vertically anywhere along this line to the bottom of the balustrade. As with balustrades for decks and balconies, gaps in balustrades on stairs cannot have openings greater than 125 millimetres. For stairs more than four metres in height, a balustrade must also not have any climbable elements, such as horizontal rails, located between 150 millimetres and 760 millimetres from the floor.

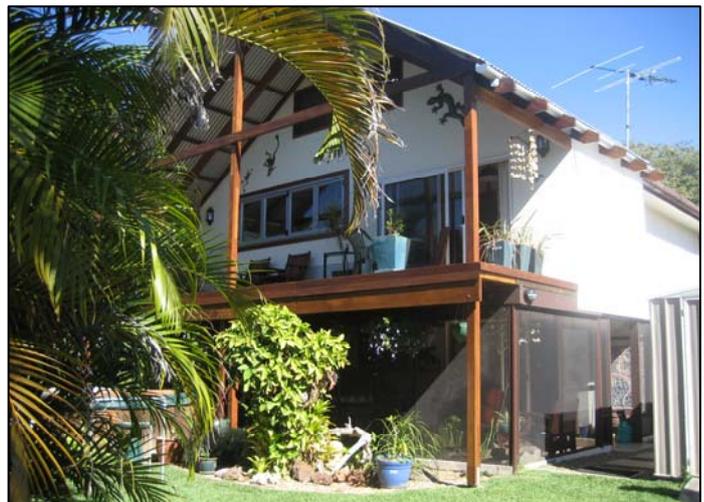
The most common reasons children fall from a deck or balcony are:

- climbing horizontal parts of balustrades
- passing through the horizontal parts of a balustrade
- climbing on furniture on a deck or balcony
- lack of supervision of children on a deck or balcony.

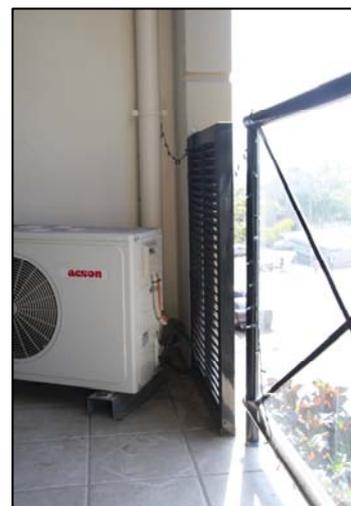
Avoid placing climbable objects close to balustrades or openable windows as shown in the picture below.

Positioning air-conditioners or other climbable objects on a balcony or deck close to a balustrade should be avoided or made non-climbable as these can be used as a foothold for children to climb on.

Similar to the pool safety requirements, it is recommended that a non-climbable arc of 900 millimetres be maintained outwards from the top of a balustrade.

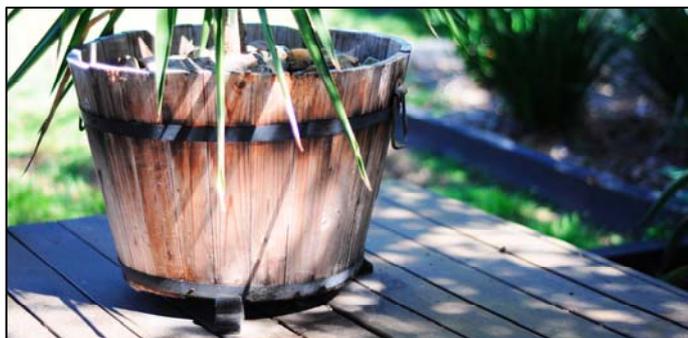
Keep trays or feet under pot plants to reduce moisture on decking.

To reduce the likelihood of decay, any areas of the deck or balcony that are frequently damp should be addressed immediately. Dampness can occur when pot plants without bottom plates or feet are placed on the deck or balcony. Soil and other debris should also be cleared away from the deck or balcony, bearers or joists (if it is a low deck or balcony), and posts or supports.

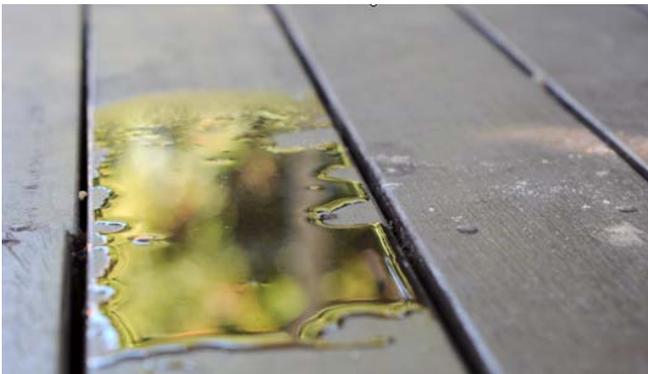
Water left on timber can cause fixings to deteriorate and rust.

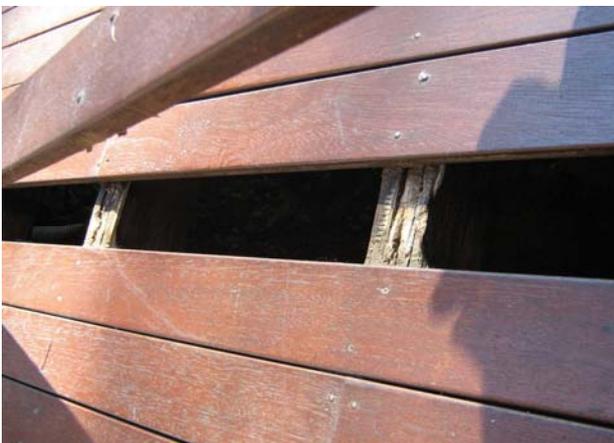
Removing this decking board has revealed a decayed joist.

Care should be taken to inspect these sections for decay and to do this adequately may require temporarily removing decking boards.

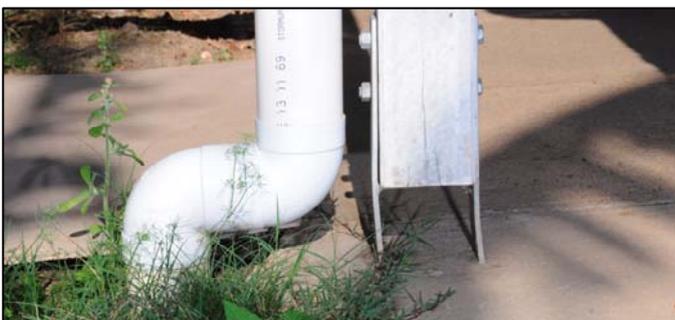
Inspect post brackets for bending or stressing.

- Bending or stress of post brackets—in most cases these brackets will be above ground level, which will make visual inspection easier.
- Deterioration of nuts, bolts, screws or nails—these fasteners can be integral to the deck or balcony and need to be free from deterioration. Rusting metal may be easier to find as it may leave a mark on the connecting timber or paint. Identify, repair and replace these areas as soon as possible.

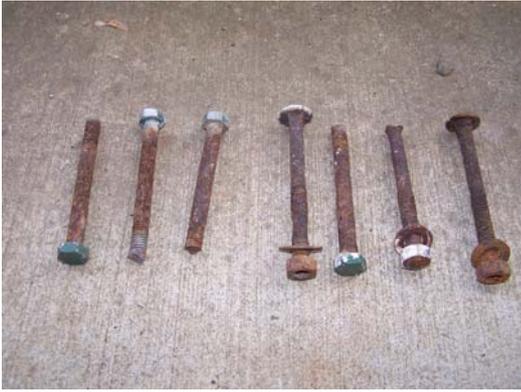
During inspections it is good practice to remove bolts to see their internal condition.

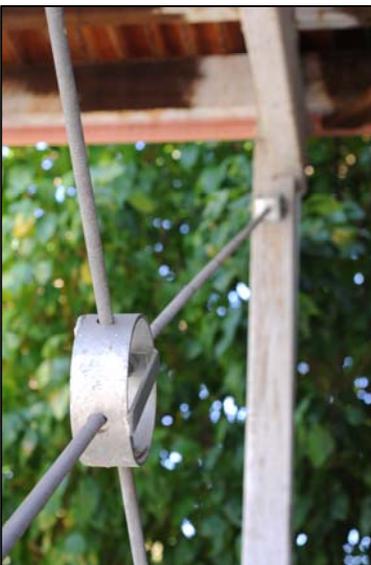
Inspect bracing on decks and balconies for undue structural movement.

Bracing is often used to support a deck or balcony, helping prevent it from moving under load. Decks and balconies can come under considerable stress from swaying or twisting. If bracing fails, there is a significant risk of harm being caused to people and property. It is therefore important to inspect any bracing of a deck or balcony to ensure there has not been any excessive structural movement.

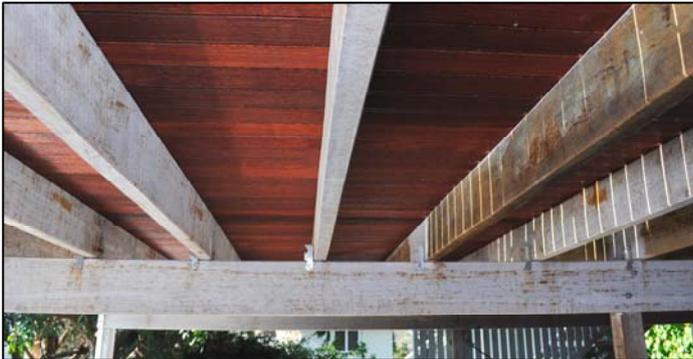
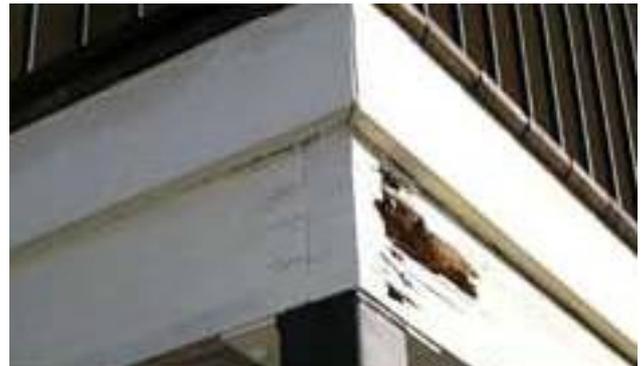
Check bearers and joists for warping or cracking.

- warped, cracked or damaged bearers or joists.
- decay and looseness at butt joints and termite damage

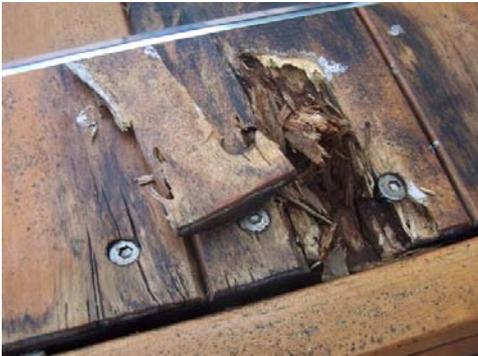
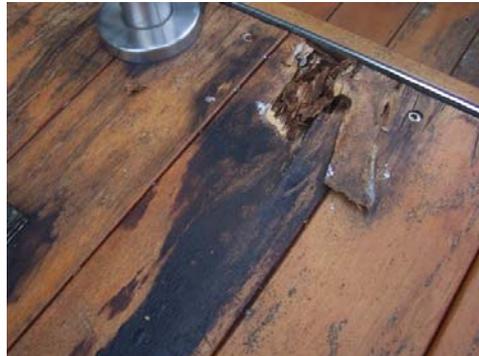
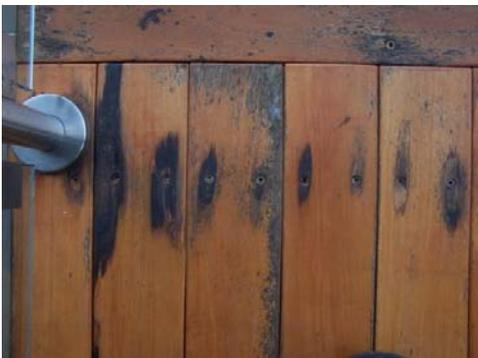
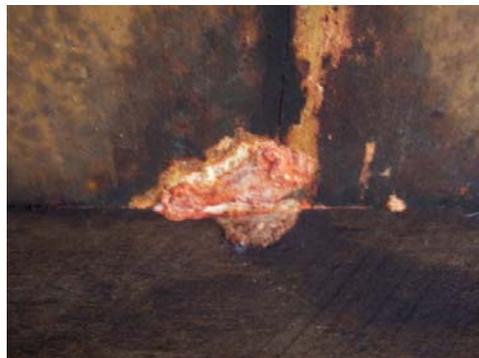
Examples of decking board decay.

Decking boards are the direct link between inhabitants and the structure. Timber boards should be inspected for decay regularly. Signs of decay include a fungus type growth on the timber, timber becoming spongy and fibrous and failure of the timber. Using a screwdriver or chisel to poke suspect timber can assist in identifying decay.

- warped, cracked or damaged decking boards
- signs of decay in timber.

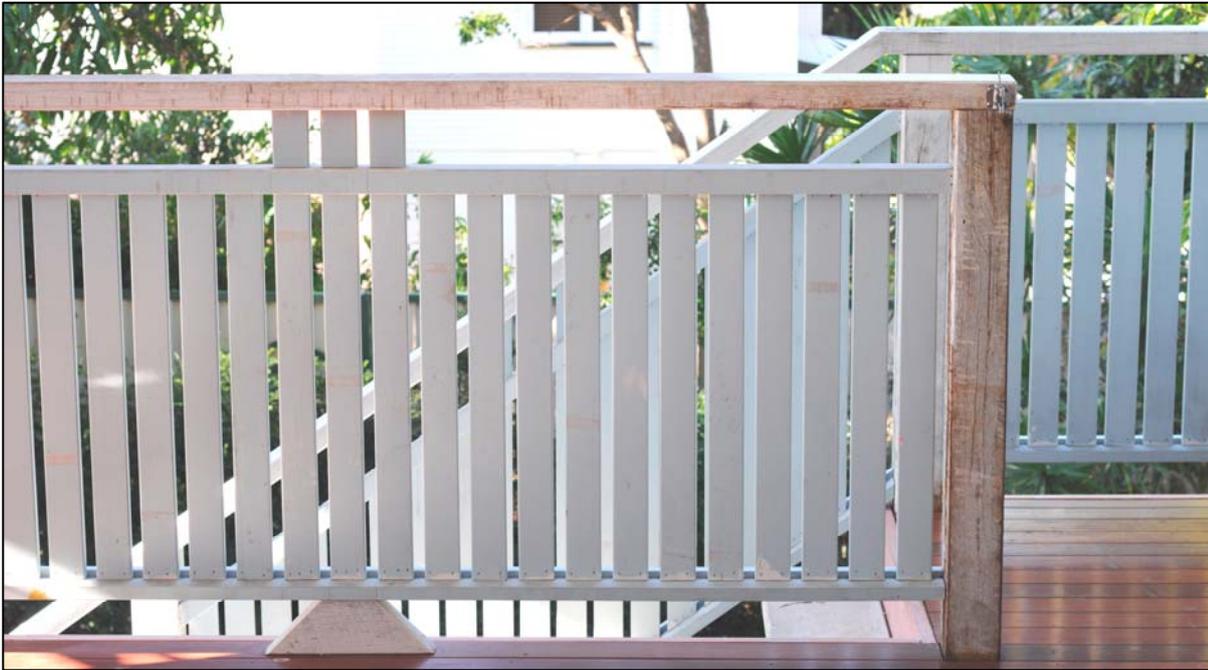
Weakened anchors for balustrades could cause them to fail if people lean against them.

Anchor points of the balustrade should be inspected regularly to ensure these are free from deterioration. Any weakening of these anchors could cause them to fail if a load was applied to the balustrade, such as a person leaning against the balustrade.

- rust and wear at anchor points (where the balustrade is fixed to the deck or balcony, walls or posts)
- handrail is securely fastened to the balustrade
- glass balustrades are free from chips or cracks
- openings in balustrade must comply with the relevant building standards.

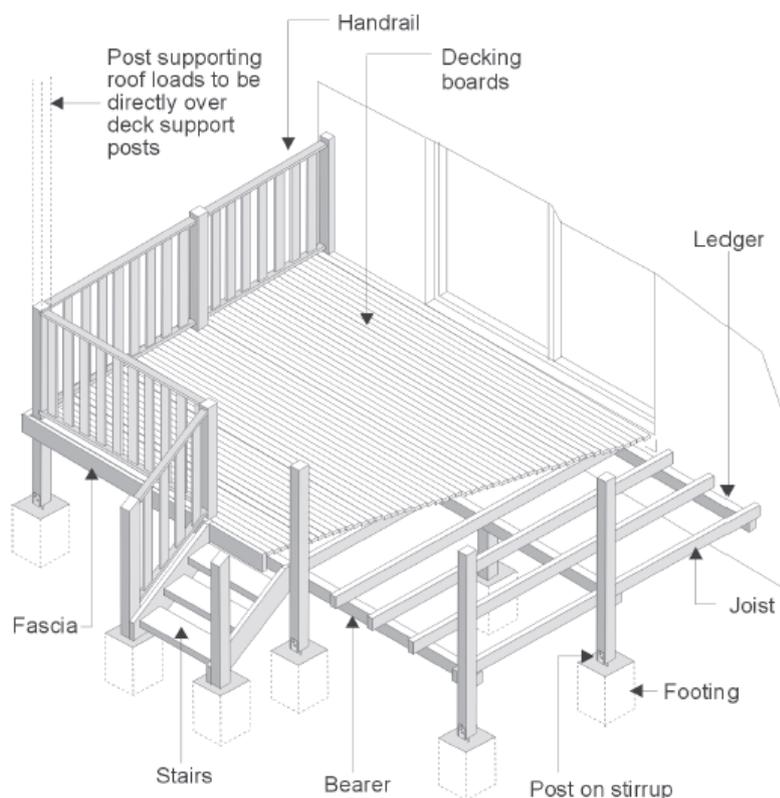
Figure 4—Example diagram showing common deck components.

Ledger—means a member that is attached to a house frame. It is designed to support a deck and transfers the weight of the deck to the house foundation.
